**SAUGUS RIVER BASIN  
SAUGUS, MASSACHUSETTS**

**GRISWOLD POND DAM  
MA 00292**

# **PHASE I INSPECTION REPORT NATIONAL DAM INSPECTION PROGRAM**

**OCTOBER 1979**

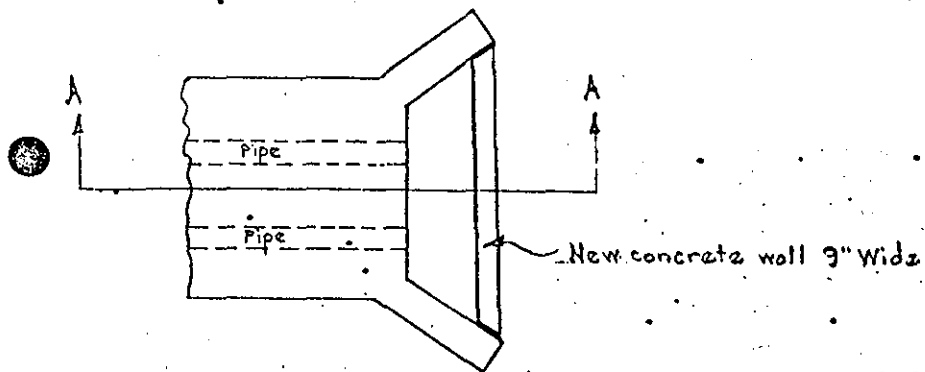
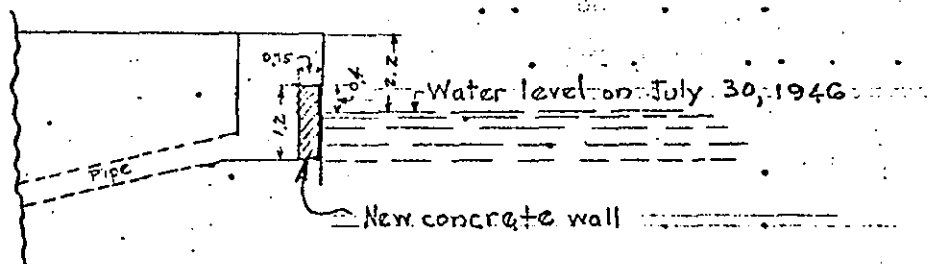
SKETCH SHOWING NEW WALL Wall built sometime between June 1944 and July 1946  
July 30, 1946

1946 July 30, S.W.Woodbury, Insp. Went to dam alone. Further inspection is needed to see that new 9" concrete wall is removed. A concrete wall 9" wide and 1'-3" high has been built across the upper end of the culvert between the wing walls which decreases the freeboard 1'-3" (see sketch) Conditions below the dam are the same. Water level today is 0.8' above the invert of the pipes. Condition of the dam is the same.

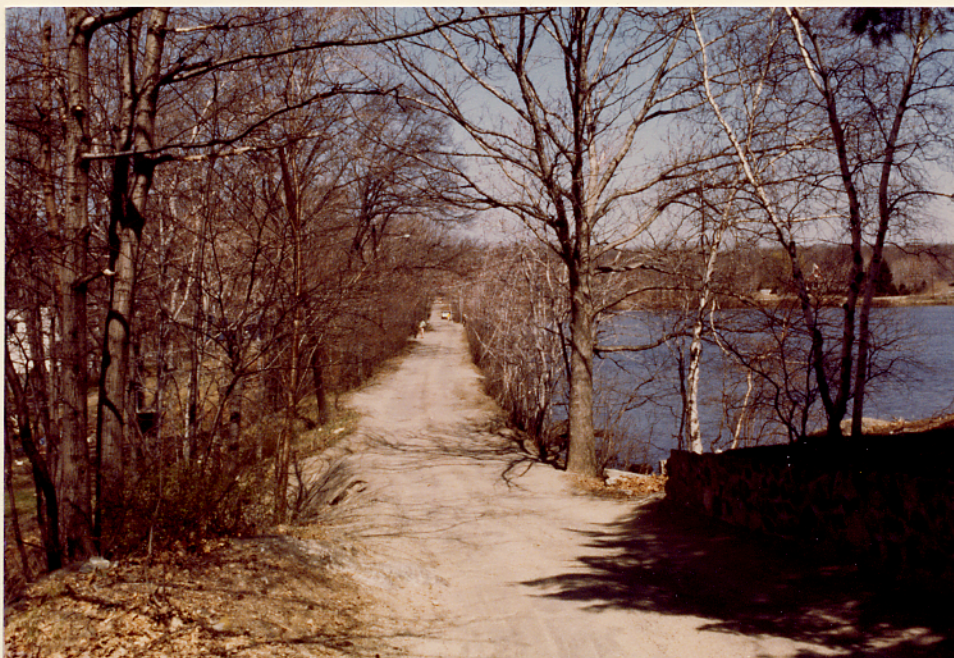
**NO. 1 CREST OF DAM**

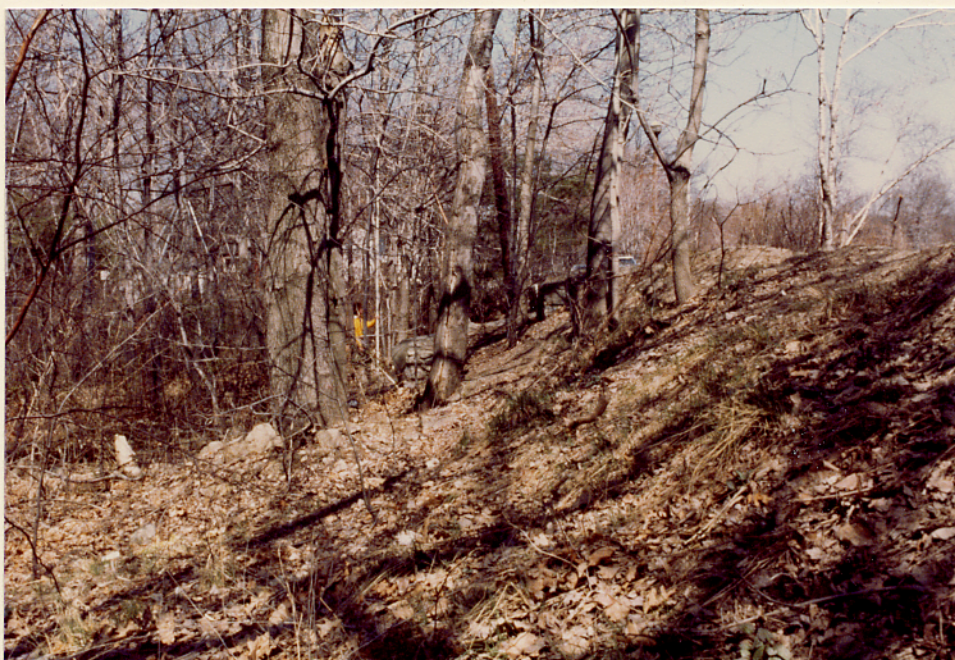
**NO. 2 DOWNSTREAM EMBANKMENT**

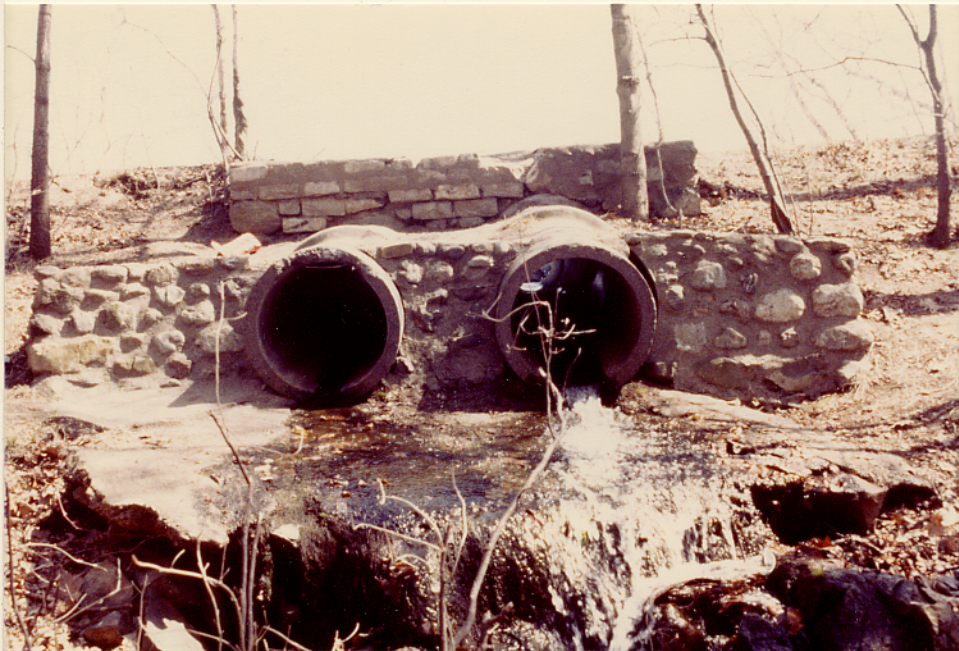
**NO. 3 DISCHARGE OUTLET CONDUITS DOWNSTREAM**

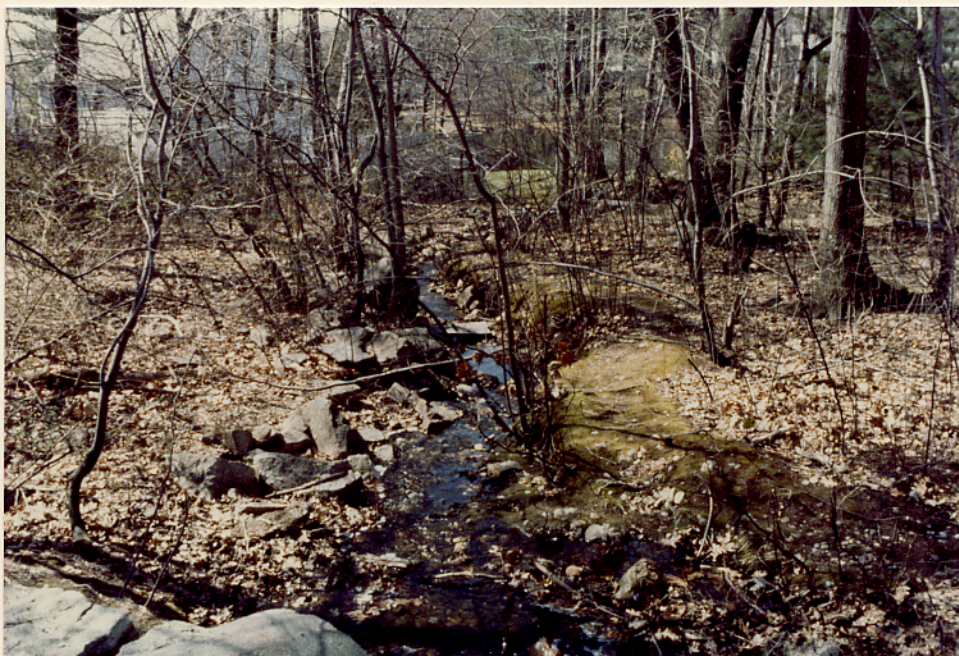
**NO. 4 DISCHARGE CHANNEL**

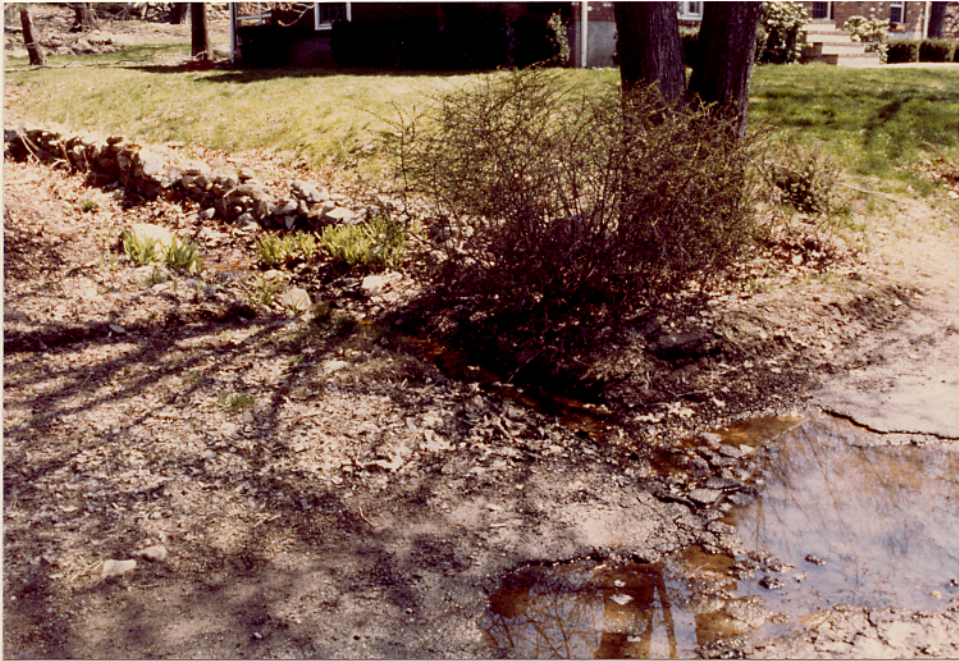
Evidence of extensive seepage was noted at the downstream toe. One seepage area was observed about 130 feet downstream from the dam. Seepage flows across Sweetwater Street, situated on the upstream edge of Lower Pond (see Photograph No. 5).

**NO. 5 SEEPAGE FROM DAM FLOWING FROM TOE**

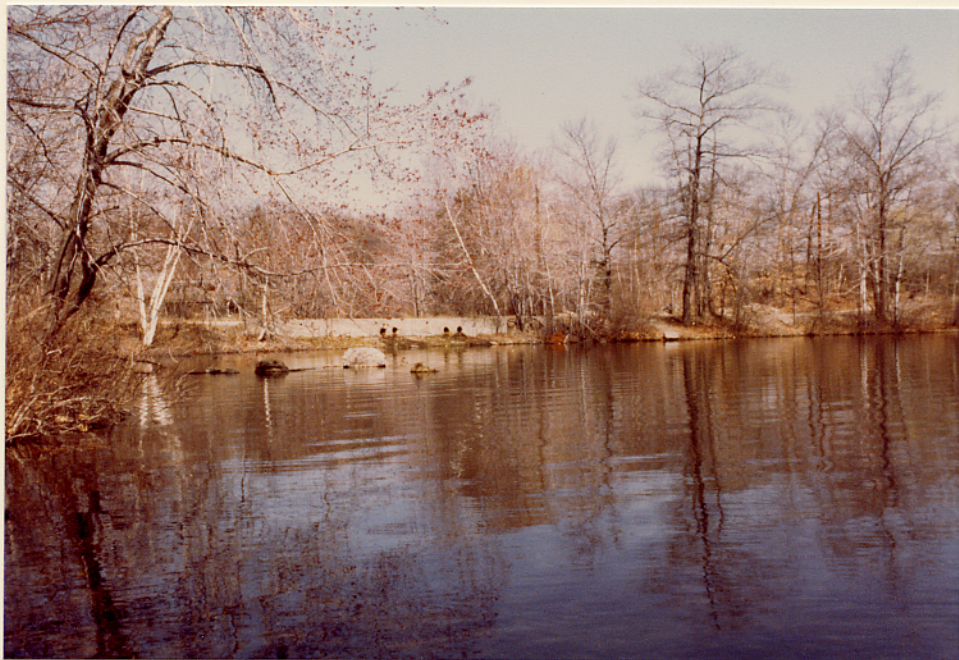
**NO. 6 INLET TO GRISWOLD POND FROM UPPER POND**
